Manhole Inspection Summary

Manhole # S29M__027MH

Location Address: **654 S Paca St**

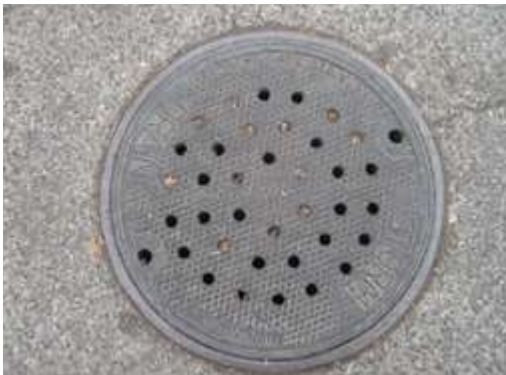
lid pic

wrong cover lid is not storm drain

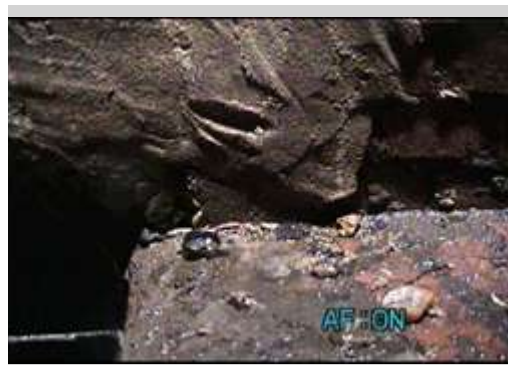
Misc

debris on bench and liquid

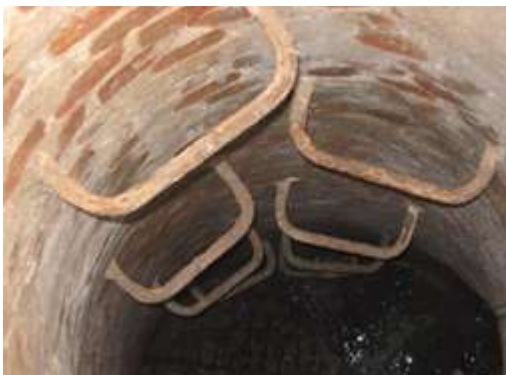
Defect 2

☒ **Corroded**

corroded rungs

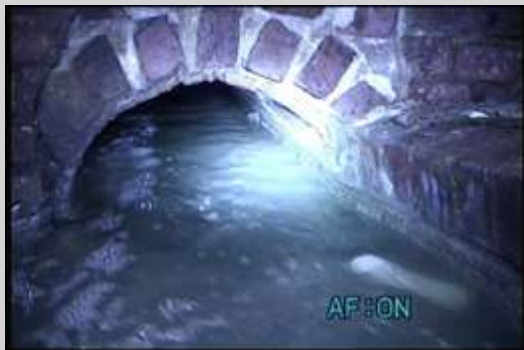
12 O'Clock Outflow

Pipe Height: **15.6** (in.) Rod and Bar (Angled)
Pipe Material: **Clay** ☐ Pipe Lined
Invert Depth: **14.59** (ft.) Flow Characteristics: **Fast**
Deposits: ☒ None ☐ Mud ☐ Sludge ☐ Debris ☐ Grease
Silt Depth: **0** (in.) Deposits Extent:
Infiltration: **None** Pipe Seal Cond: **Sound**

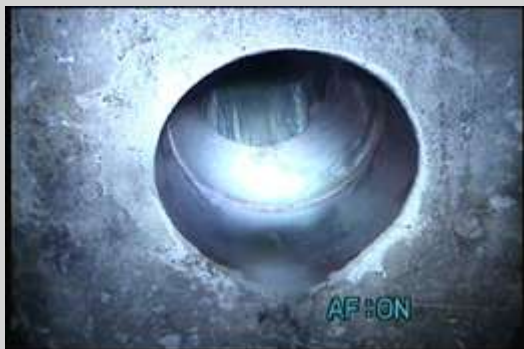
4 O'Clock Inflow

Pipe Height: **15.6** (in.) Rod and Bar (Angled)
Pipe Material: **Clay** ☐ Pipe Lined
Invert Depth: **11.84** (ft.) Flow Characteristics: **Fast**
Deposits: ☒ None ☐ Mud ☐ Sludge ☐ Debris ☐ Grease
Silt Depth: **0** (in.) Deposits Extent:
Infiltration: **None** Pipe Seal Cond: **Sound**

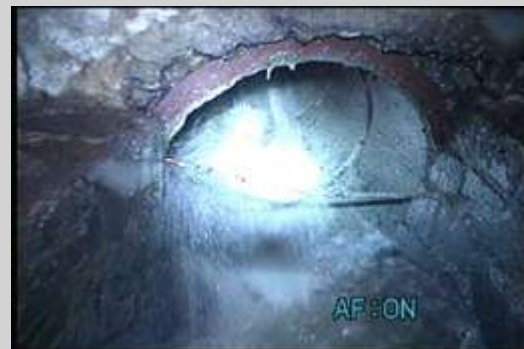
Drop In @ 4 O'Clock

Drop: **Outside** Rod and Bar
Angled: **Yes** Reading: **13.24** (ft.)
Inv Depth: **14.24** (ft.)
Drop Condition: **Open**

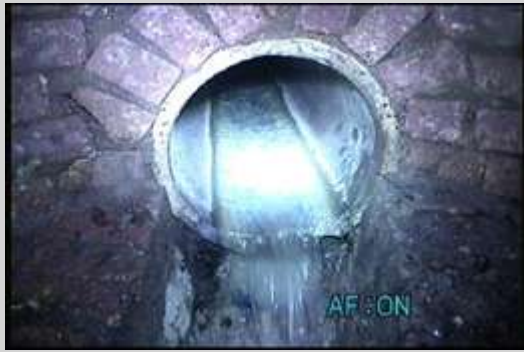
7 O'Clock Inflow

Pipe Height: **10.8** (in.) Rod and Bar (Angled)

Infiltration: **None** Pipe Seal Cond: **Sound**

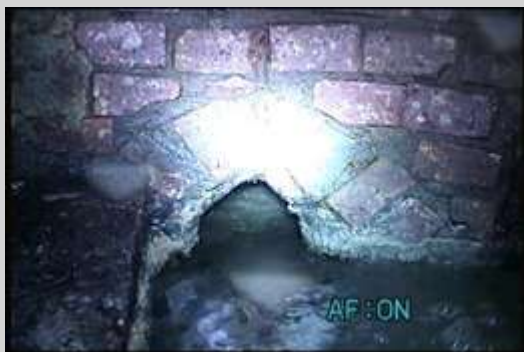
11 O'Clock Inflow

Pipe Height: **8.4** (in.) Rod and Bar (Angled)

Infiltration: **None** Pipe Seal Cond: **Unknown**
